TROUBLESHOOTING OF INTERMITTENT AEM[®] MONITOR ALARMS

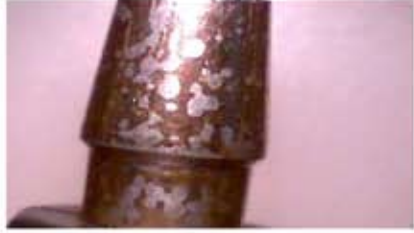
Damage to Gold Connector	Residue on Gold Connector
What this looks like:

Causes:	<ul style="list-style-type: none"> • Use of metal brushes or metal scouring pads • Use of chlorine products (like bleach) • Prolonged exposure to salt solutions (like saline) 	<ul style="list-style-type: none"> • Detergent not completely dissolved prior to washing • Detergent not completely washed off • Instrument positioned in washer/dryer so that detergent remains trapped • Mineral deposits from water
Recommendations:	<ul style="list-style-type: none"> • Use soft-bristled nylon brushes • DO NOT USE BLEACH PRODUCTS • Do not soak metal instruments in saline solutions for prolonged times • Do not allow saline, blood, or organic debris to dry on instruments prior to cleaning 	<ul style="list-style-type: none"> • Completely dissolve detergents prior to use • Rinse products for at least 3 minutes under running water to remove detergents • Position instruments so that they drain freely (Fixed-Tip Electrodes shroud <u>down</u>) • Use distilled water as a final rinse • Use an alcohol swab on the electrode to remove residues <u>prior</u> to sterilization*

*Excessive residue buildups may require several treatments with an alcohol swab.
